REPORT OF INVESTIGATION

Fatal Machinery Accident
November 10, 2003

A&I Contracting, Inc. (D-540)
Salyersville, Kentucky

17 Mine
Knott Floyd Land Company, Inc.
Hueysville, Floyd County, Kentucky
ID No. 15-18444

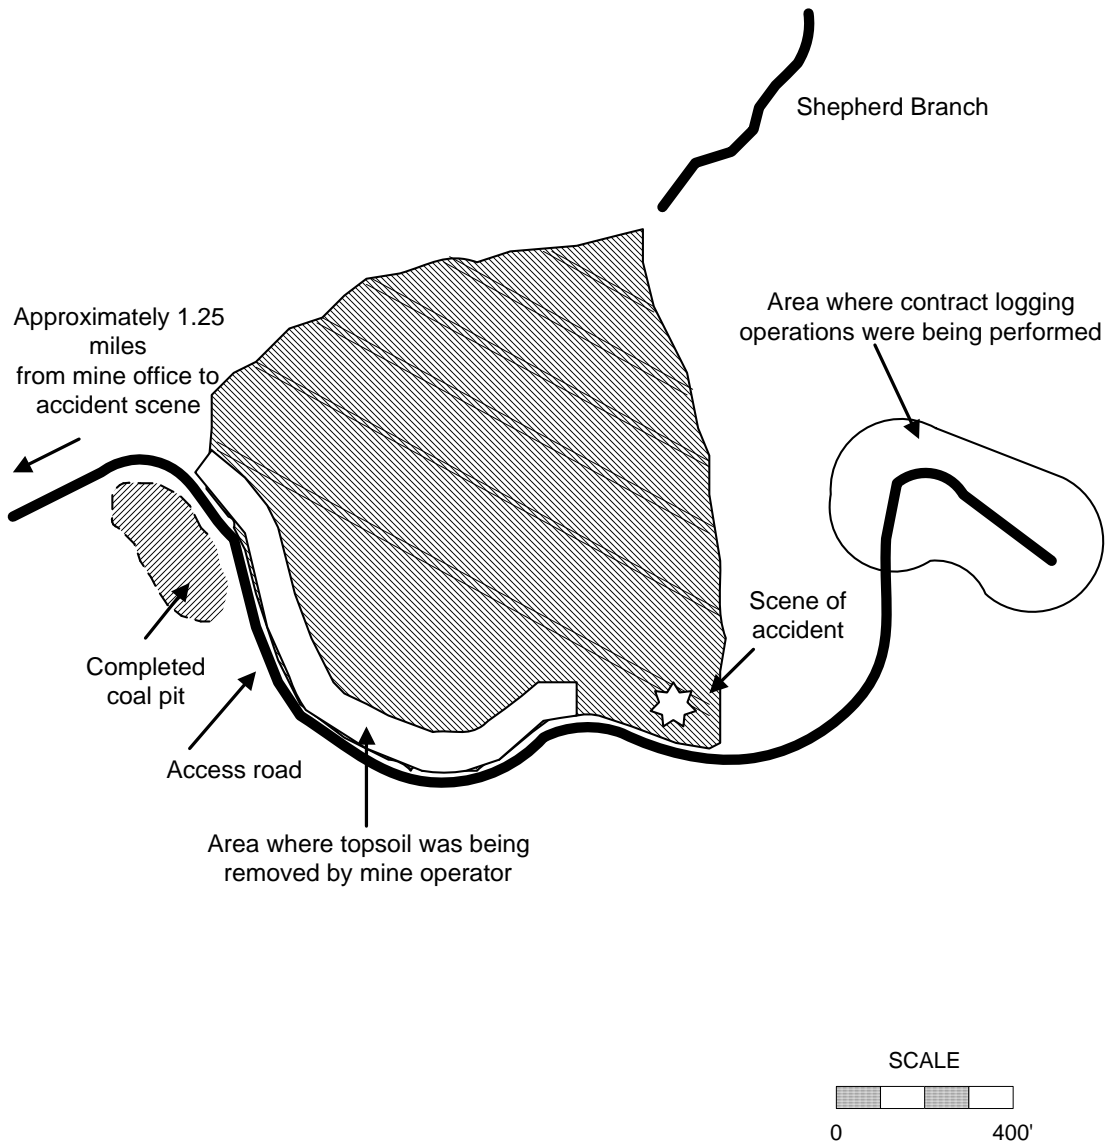
ACCIDENT SITE

As the tree fell, the undersized notch closed prematurely, placing stress on the remaining uncut wood. This caused the tree to split vertically for a distance of approximately 13-feet. The split-off slab of the tree apparently struck the victim in the face and then fell on top of him.

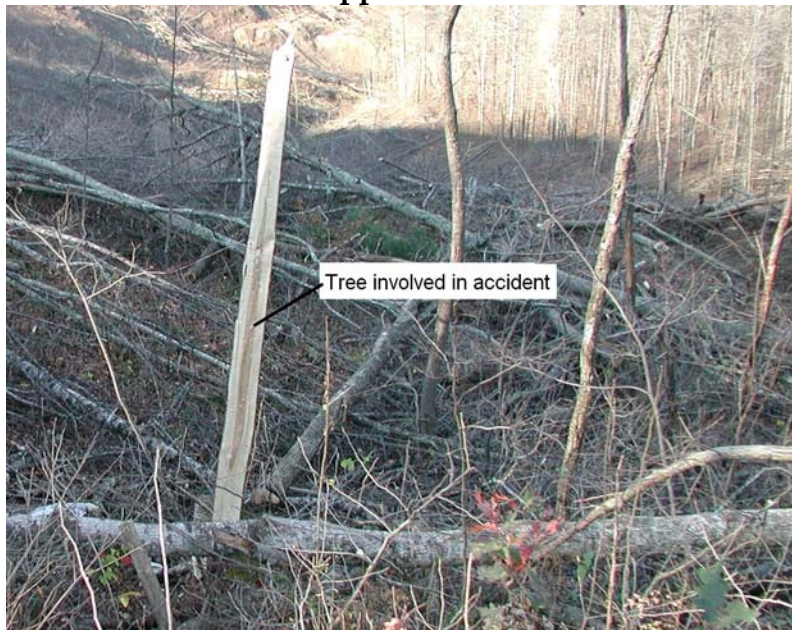
Photograph of Accident Scene

Corrective Action: Adequate training in proper methods for cutting trees.
Adequate management oversight to insure safe methods are followed.

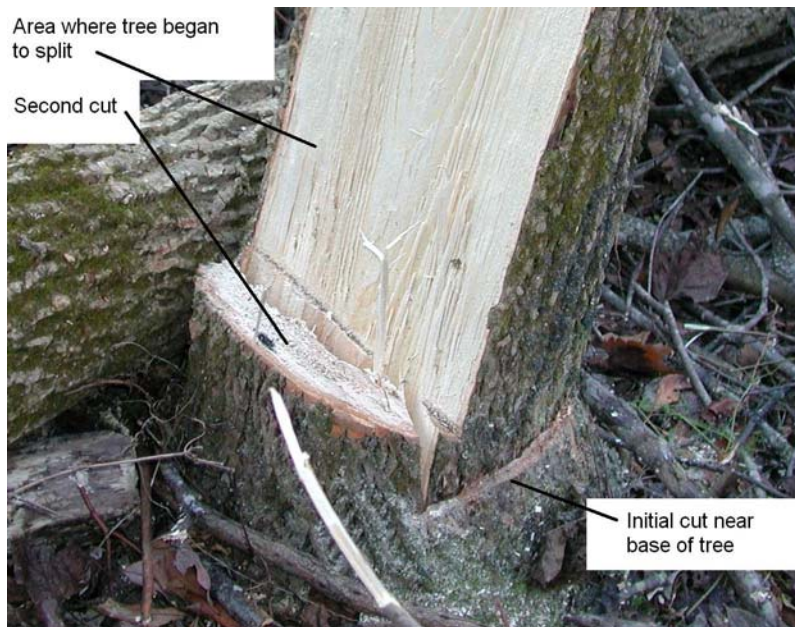
Although the tree was cut using the Open Face Notch practice, the notch was not of sufficient size to allow safe felling of the tree. A notch is the portion of wood removed from the tree during the initial steps of felling. A properly cut notch will close just before the tree hits the ground, providing a higher degree of safety and less chance of kick back. Kick back is a sudden, violent release of a portion or slab of the tree being cut, due to breakage of the hinge or splitting of the tree. A horizontal cut was made approximately 8-inches into the tree, followed by a top cut to the same depth, creating a notch. The wedge removed from this notch measured approximately 2.25-inches thick at the thickest part. A properly sized notch would have resulted in a wedge measuring approximately 10-inches to 13-inches at its thickest part.

The amount of uncut material left in the tree trunk was not sufficient to form a proper hinge for control of the falling tree. A hinge is the uncut wood left intact in the tree stump during felling. It provides a means for controlling the direction of the fall and holds the tree to the stump during most of the fall. The hinge resulting from the proper cutting technique will remain intact until the tree hits the ground, further reducing the risk of kick back.

The felling or back cut was made into the opposite side of the tree on a slightly downward angle. This cut penetrated beyond the notch cut, and left less than 3-inches of uncut wood supporting the tree.

Close up of Base of Tree
